CUMBERLAND CONSERVATION DISTRICT

HISTORIC AREA PRESERVATION PLAN

HA-32 (CMB)

**A PART OF THE
COMPREHENSIVE PLAN
FOR MARION COUNTY, INDIANA**

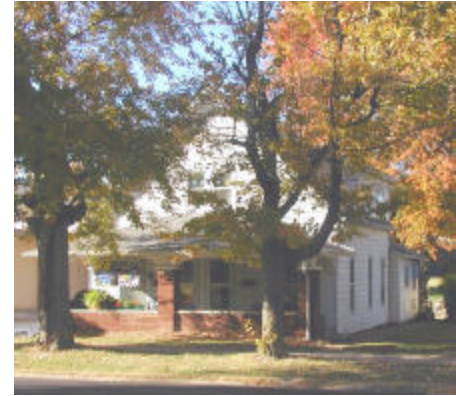
House
12015 E. Washington St.
c. 1915
Contributing

Description: This 1-story Arts & Crafts house has a rectangular footprint, a front-gable roof, wood clapboard siding, and three-over-one Craftsman style windows. An off-center partial-width porch is located on the front façade and has a prominent front gable roof and substantial brick porch supports.

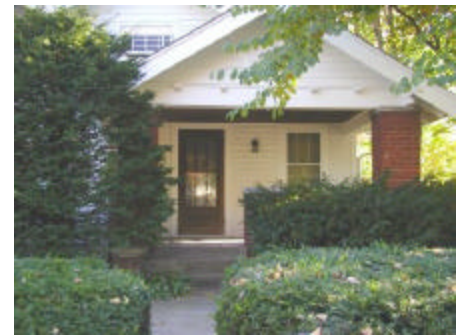
House
12023 E. Washington St.
c. 1910
Contributing

Description: This 1½-story Arts & Crafts style house has experienced very few changes since its date of construction. The house features a side gable roof with clipped gables and a central front gable dormer, wood clapboard wall siding, four-over-one double hung wood windows, and original French entry door. A partial-width porch spans the front façade and has a combination brick and wood balustrade. The central front dormer is accentuated by paired windows and a balconette.

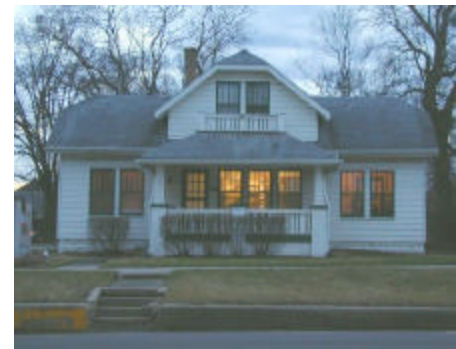
Caylor-Kitley House
12024 E. Washington St.
c. 1900
Contributing

Description: William Caylor, who resided at 11825 Colmar St. and operated Caylor's Grocery store on the National Road, built this house. Floyd and Alma Kitley later owned the house. Mr. Kitley was a mechanic in the garage on this property.

Characteristic of the Queen Anne style, the 2-story Caylor-Kitley house has a steeply-pitched cross gable roof, artificial siding, and large one-over-one windows. A brick porch spans the full-width of the front elevation and wraps around a portion of the west elevation.

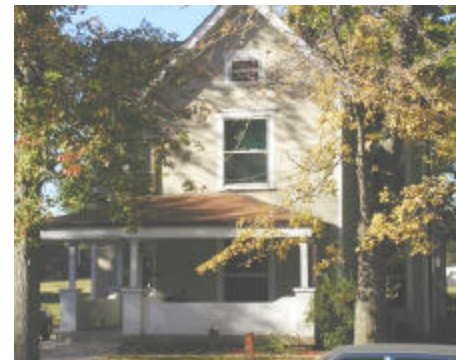
House
12029 E. Washington St.
c. 1910
Contributing

Description: This 2-story American Foursquare features a low pitched hipped roof, a symmetrical façade, wood siding, one-over-one windows, and a small 1-story addition on the rear elevation. An open, full-width brick front porch spans the front façade, and has a brick balustrade and brick porch supports.

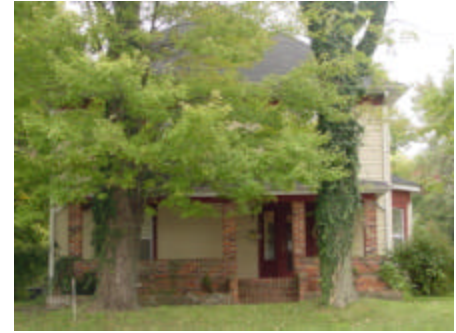
House
12030 E. Washington St.
c. 1900
Contributing

Description: This 2-story Queen Anne style house has experienced very few alterations since its time of construction. Defining architectural features include a steeply-pitch cross gabled roof covered with slate tiles, built-in gutters and downspouts, wood clapboard siding, and one-over-one double hung wood windows. A full width porch spans the front façade and is supported by simple wood porch posts. Historically, the porch had a decorative balustrade that has since been removed.

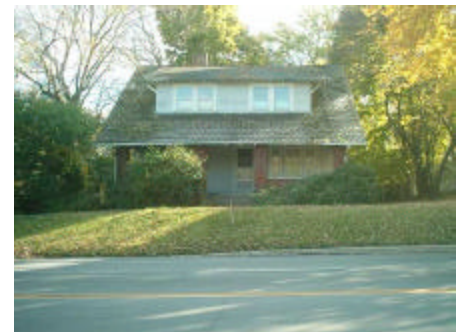
Description: During the 1950s and 1960s, this building served as the local drive-up car hop restaurant.

Altered since its time of construction, the building now features vertical board siding, a neo-mansard roof covered with asphalt shingles, and a typical contemporary storefront entrance.

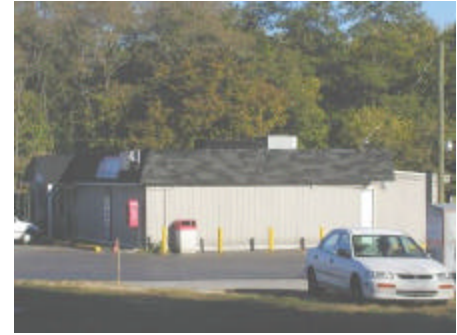
Commercial Building
12050 E. Washington St.
c. 1999
Non-Contributing

Description: This prototypical commercial building has a flat roof, brick veneer wall cladding, a large corrugated metal cornice, and a typical contemporary storefront entrance.

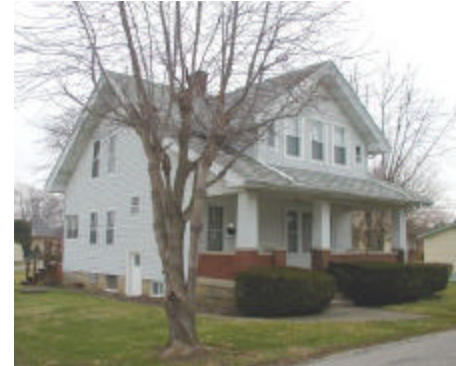
House
25 N. Wayburn St.
c. 1915
Contributing

Description: This 1½-story Craftsman-style bungalow features a side gable roof with a large central front-gable dormer, wide overhanging eaves, artificial siding, one-over-one windows, and a cast stone foundation. A full-width brick porch spans the front façade and is supported by three battered wood piers.

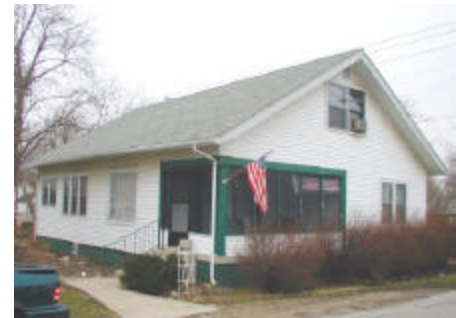
House
26 N. Wayburn St.
c. 1920
Contributing

Description: Expressing only minimal stylistic details, this 1-story front-gable house features wood clapboard siding, several groupings of paired Craftsman-style wood windows, and an integrated partial width front porch.

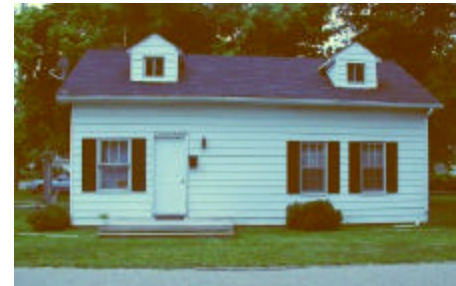
House
24 S. Wayburn St.
c. 1940
Contributing

Description: This small 1-story house represents the Minimal Traditional style, which was popular around WWII. The house features a side gable roof with two small front gable dormers, aluminum wall cladding, three-over-one wood windows, and an off center front entry door.

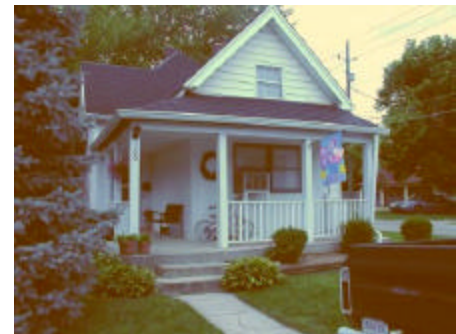
House
100 S. Wayburn St.
c. 1900
Contributing

Description: This 1½-story house has a cross-gable roof, artificial siding, one-over-one windows, and a wrap-around porch. Although some historic materials were replaced, the house retains its original shape and dimensions.

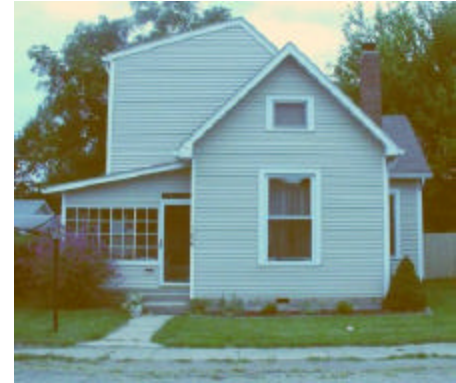
House
106 S. Wayburn St.
c. 1900
Contributing

Description: At its time of construction, this modest 1½- story cross-gabled house was most likely a small Folk Victorian cottage. Several significant alterations were made to the house, including the addition of vinyl siding, vinyl windows, an enclosed shed porch addition, and a large second story addition that projects beyond the original roofline of the house.

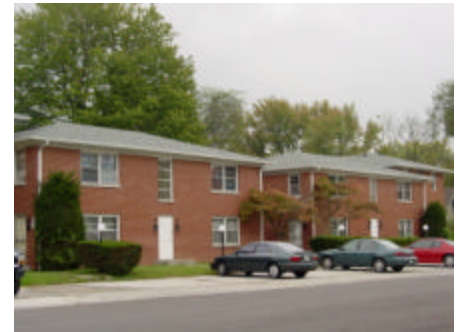
Apartment Buildings
107 S. Wayburn St.
c. 1960
Non-Contributing

Description: The lack of decorative detailing on these two apartment buildings is characteristic of 1960 architecture. The structures have very low-pitched hipped roofs, brick veneer wall cladding and paired metal windows.

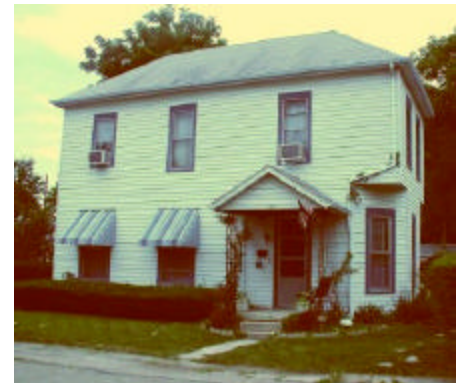
House
112 S. Wayburn St.
c. 1890
Contributing

Description: This 2-story house has a low-pitched hipped roof, artificial siding, and long narrow one-over-one wood windows. The off-center front entry door is covered by a front-gable portico with metal porch supports.

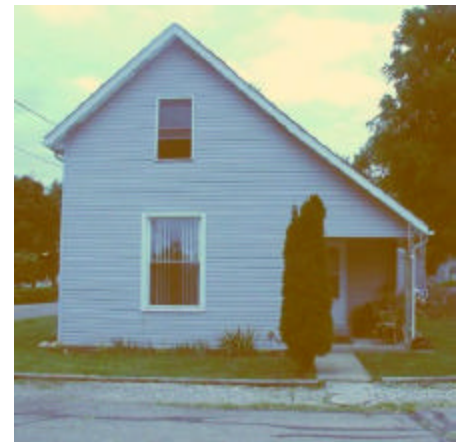
House
120 S. Wayburn St.
c. 1900
Contributing

Description: This 1½-story front gabled house has endured some significant alterations. The original wood clapboard siding was covered with new vinyl siding, and the original wood windows were replaced with vinyl one-over-one windows. The shed roof covering the partial width integrated front porch is not original. Historically, the house most likely had a wood porch.

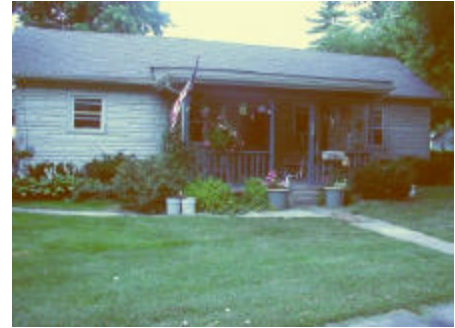
House
224 S. Wayburn St.
c. 1940
Contributing

Description: Characteristic of post-war architecture, this minimal traditional style house has a low-pitched side-gable roof, limestone veneer wall cladding, and one-over-one windows. A partial width porch covers a central entryway and has a simple wood balustrade and porch supports.
